Stone World

Reviving the stonework of a Philadelphia landmark

The Carrara marble in the members' shower area of the historic Racquet Club of Philadelphia was repaired and replaced to bring back its original grandeur

Racquet Club of Philadelphia (members’ shower area)

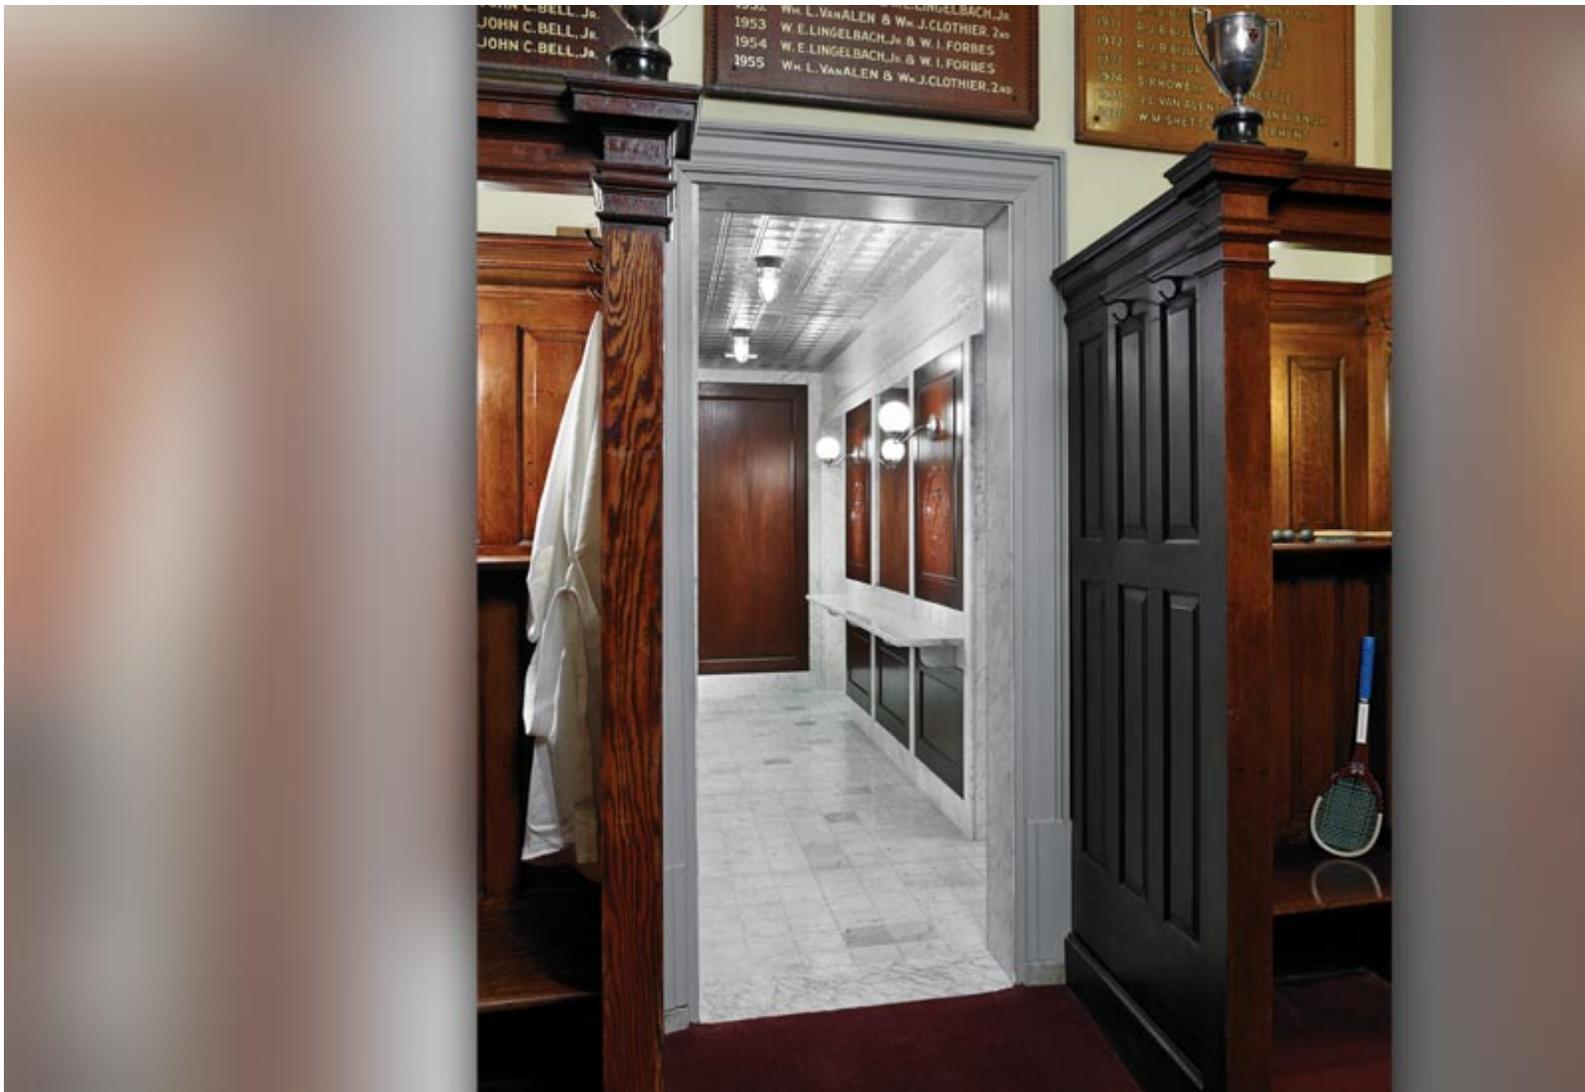
The white Italian marble pairs well with the mahogany woodwork, creating a sophisticated and well-designed space.
